The Cause and Origin of The Hartford Circus Fire

A Study of the Investigations

by M. Skidgell ~ July 1, 2015

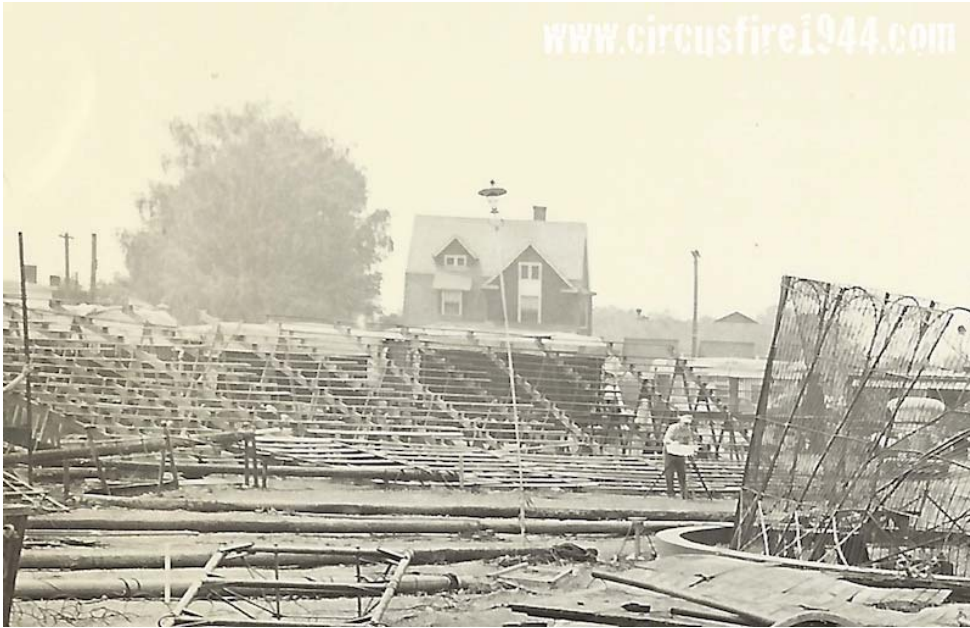
Photo 2: The southwest bleachers, mostly intact after the fire.

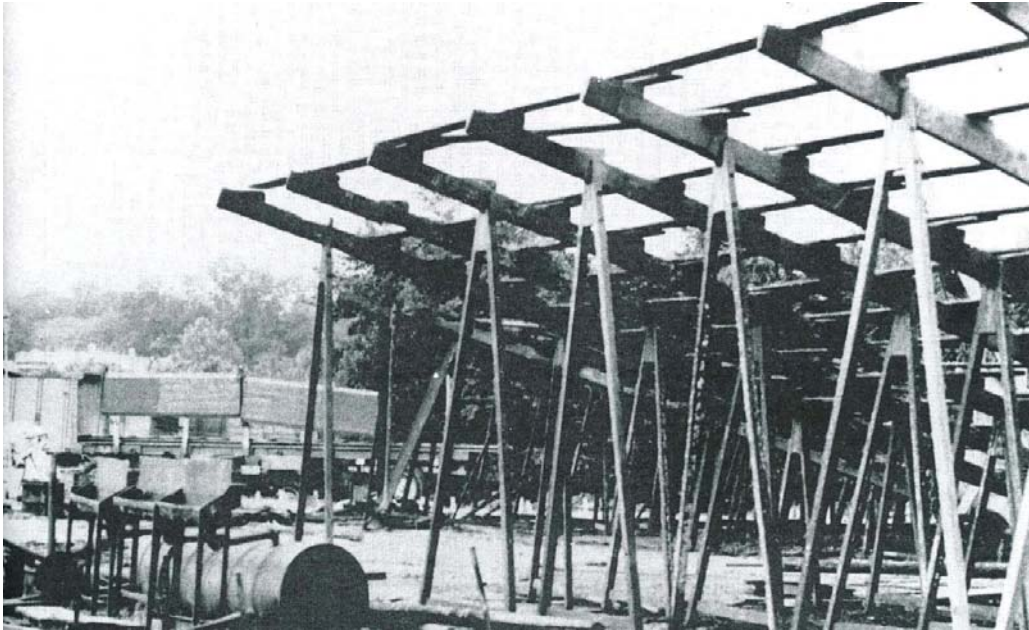
Photo 3: The origin of the fire was in this area behind the southwest bleachers. Charred support jacks are still standing beneath the bleacher seats. The tank and plumbing on the left mark the location of the men's toilet enclosure.

Coroner Healy also questioned Fire Marshal Brophy about his investigation of the fire scene and the evidence. Brophy explained, *“I went over the entire ground.... Where the men's toilet was located, there were some jacks supporting the seats shown to me. At one point where one of the jacks had been removed, I noticed that the fire had travelled in a northerly direction, particularly under the seats... the further north*

you went, the deeper the charring became. South of where this jack was burned... there was less burning on the supports and on the seats, and a short distance away the paint had hardly been blistered by the heat.... I made an examination of the jack... at the bottom of the jack it was heavily charred and carbonized, showing there was intense heat at that point. It is possible, in my opinion, a piece of the side wall might have dropped to that point. I don't know how long that fire was burning at the bottom of the jack. I don't know whether the bottom of the side wall was draped against the wooden jack... I believe there was something else outside of the wooden jack that was first ignited. I don't believe that a match or cigarette could ignite that wooden jack... If there was sufficient combustible material at or near that point, it probably would... From the information furnished to me by Chief Hickey, it is possible that the fire may have been caused by a cigarette or open match flame. I don't know what the physical conditions were at the time of origin, nor do I know whether or not there was any combustible material deposited at or near the point of origin at the time of the fire."

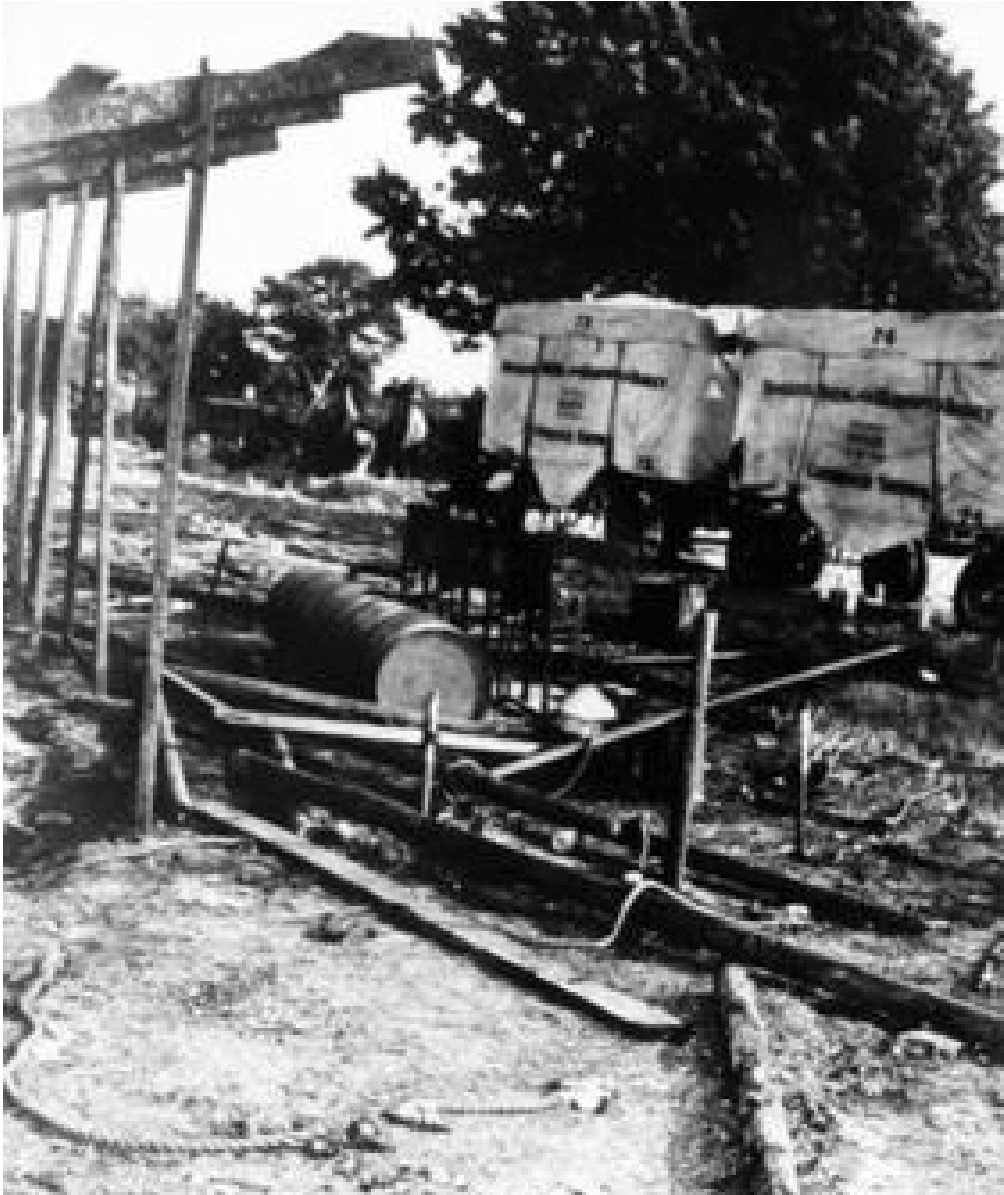
Photo 4: Another view of the southwest bleacher support jacks, and the men's room area.

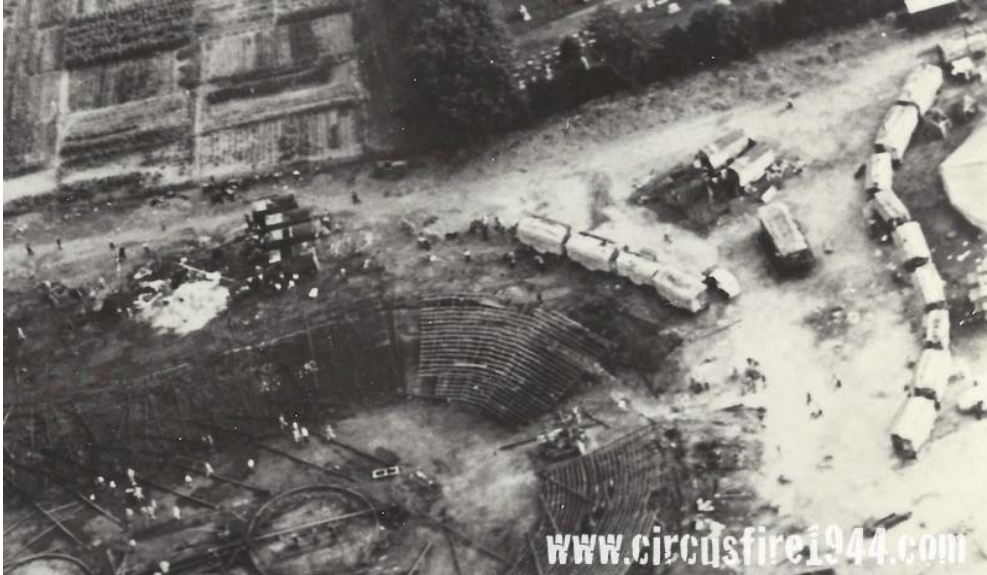
Photo 5: Aerial view of the big top ruins. The fire originated in the southwest bleacher area, center of photo.

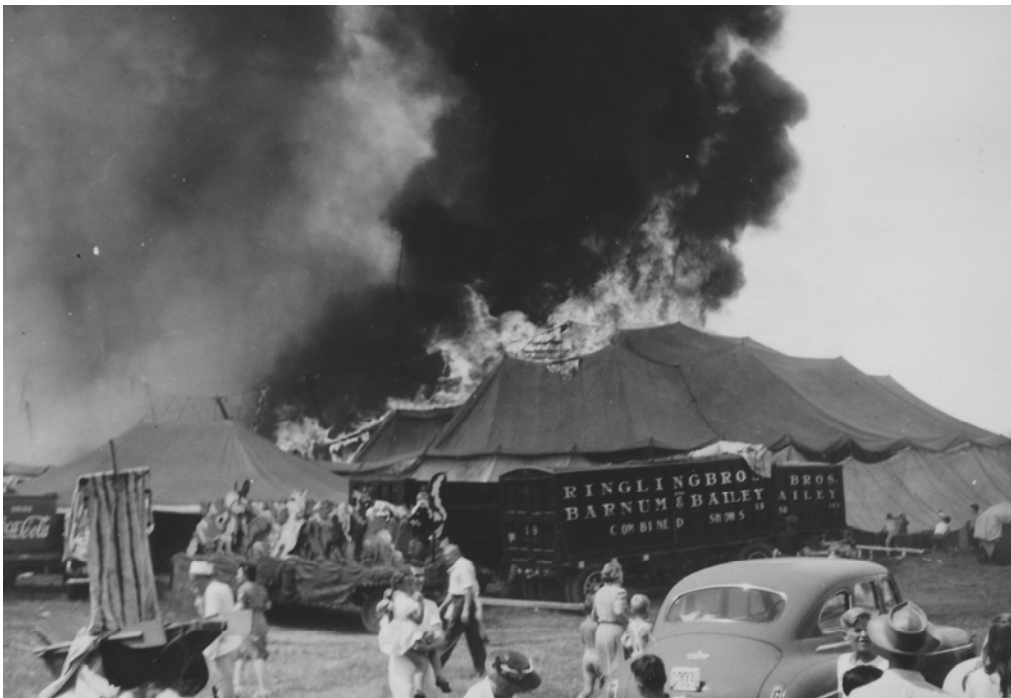
Photo 6: The big top in flames. Men can be seen lifting the canvas sidewalls to help others escape.

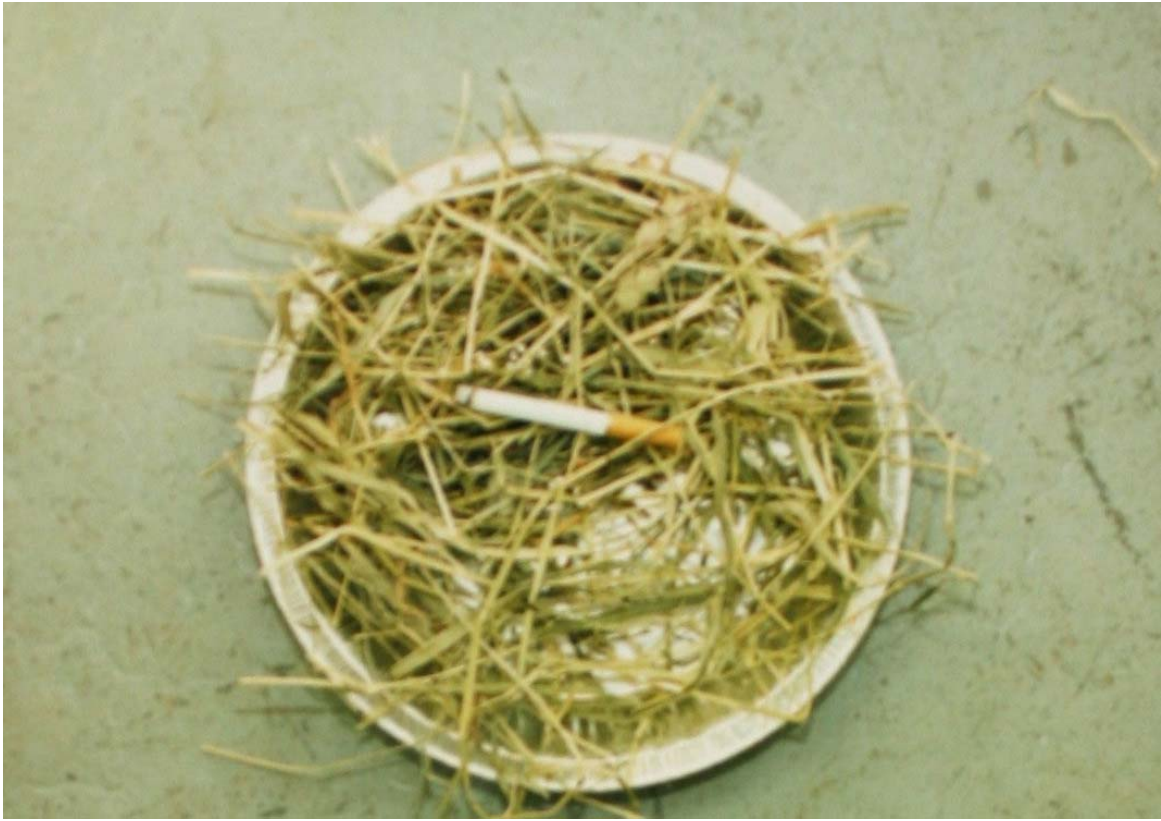
Photo 9: Photo from the 1993 Forensic Report showing a lit cigarette in a tray of dried grass.

Focusing on Commissioner Hickey's 1945 determination that a lit cigarette ignited grass which in turn spread to the support jack and the canvas, Detective Lewis' investigation uncovered the results of a test conducted between 2:00 and 4:00 PM on July 25, 1967 in which lit cigarettes were dropped into grass. *"The report concluded that cigarettes would not start grass fires when the humidity was above 22% and matches would not start grass fires above 78%."* Lewis, looking to confirm these results, arranged for Dr. Henry Lee of the State Police Forensic Science Laboratory to perform a series of tests to determine if a cigarette would indeed ignite grass under similar weather conditions as were in place on July 6, 1944. The team of criminalists' conclusion, after conducting their own tests in April, 1993, was that: *"the cigarette only generated a limited amount of heat and energy, compared to the reported required 350 degree Fahrenheit average ignition temp for dried grass. Therefore it is difficult to ignite freshly cut grass with a cigarette. Laboratory experiments using zero moisture content for the grasses also failed to result in ignition. Therefore, a lit cigarette in grass or hay is inconsistent as the cause of the Hartford circus fire of July 6, 1944...Whether or not other materials, such as paraffin wax, matches, gasoline residues, and other combustible materials were present in the men's room near the main tent on July 6, 1944 is unclear at this time. If these materials were present, it would have changed the ignition conditions at the time of the fire. Based on other investigator's test results, if the relative humidity is greater than*

18% no ignition of cigarettes will take place. There may be ignition of grasses if other conditions are right and if the relative humidity is less than eighteen percent. These results and our own studies with the records indicating the humidity on July 6, 1944 was approximately 60% suggest that the ignition of the fire by a cigarette on or in the grass would have been difficult.” Only cigarettes (filtered and non-filtered) were used for these tests; no other or ignition methods were tested.

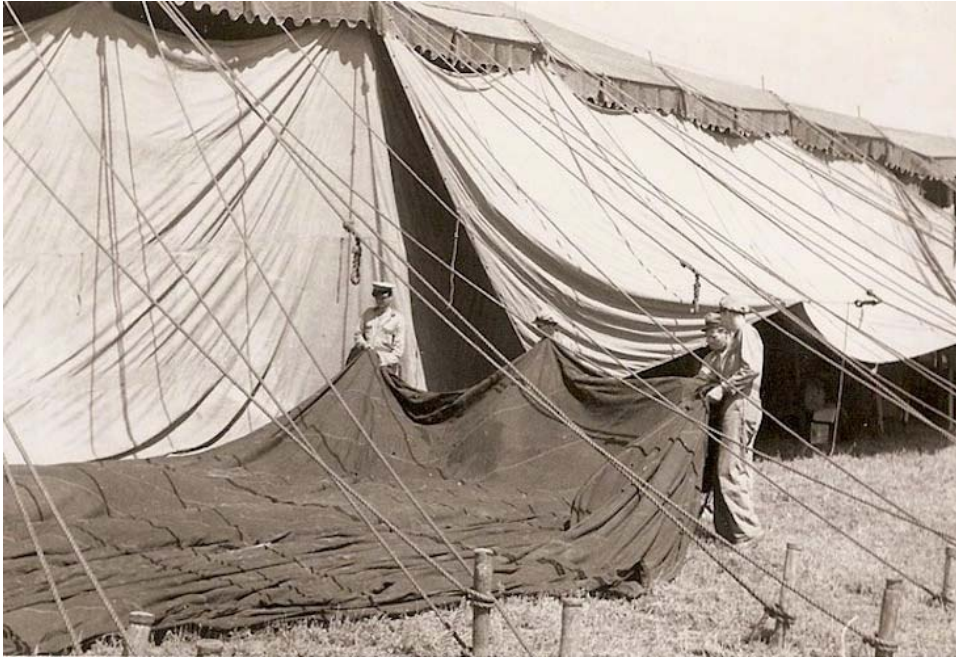
Photo 11: Circus workers installing canvas. The tops of the canvas sidewalls are not lowered in this photo.

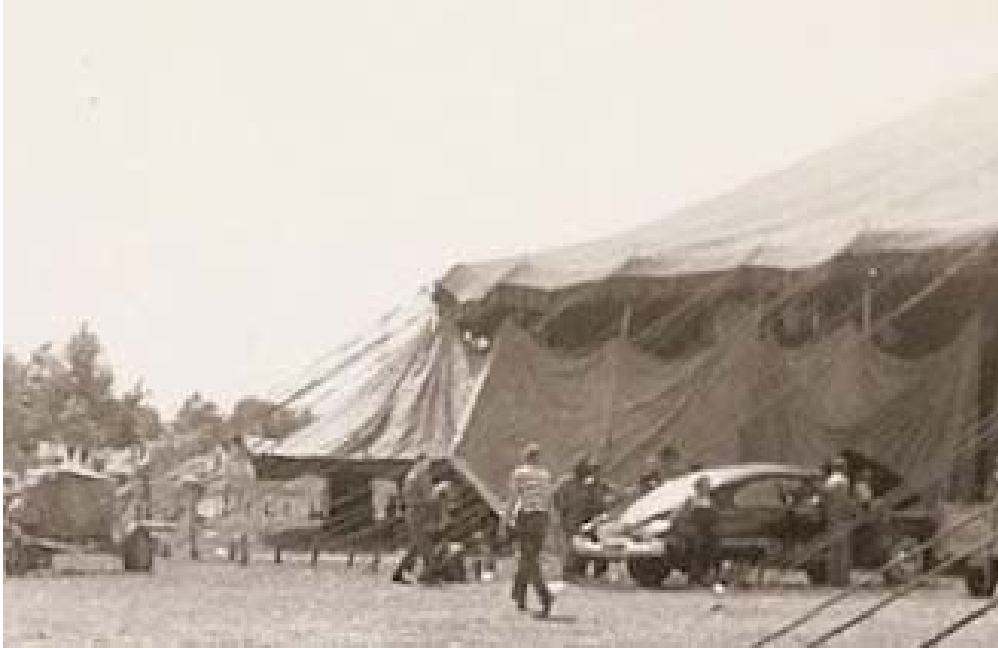
Photo 12: The tops of the canvas sidewalls are lowered to allow airflow into the tent.

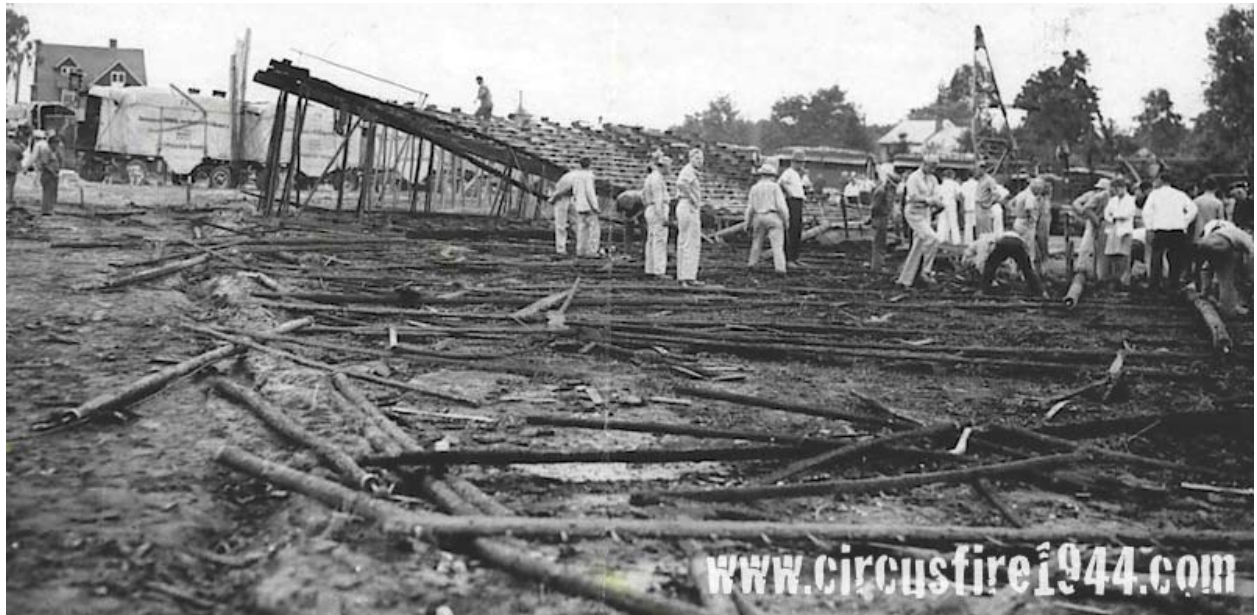
Photo 15: The southwest bleachers remain standing in the center of the photo, while the reserved seating section in the foreground has been thoroughly destroyed.
